**POINT ARENA  
SCHOOLS DISTRICT**

**FACILITY ASSESSMENT**

July 2018

Alameida  
Architecture

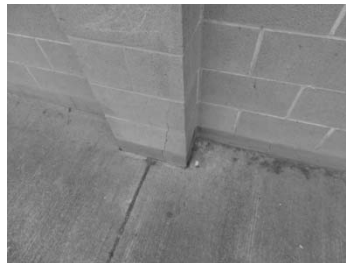
*The building overall appears to be resting on firm and stable foundation with the exception of one location where cracking is evident at one concrete block pilaster, doesn't seem to be from differential settlement. it should be monitored periodically to determine if it is expanding or dormant.*

*Stress crack at Gymnasium column pilaster*

1. *Replace remaining exterior doors, particularly high use doors with FRP continuous hinged doors.*
2. *Replace east facing upper windows with insulated panels, or restore windows to original condition and add exterior louvers to mitigate glare.*
3. *Paint Exterior in five or six years.*
4. *Monitor stress crack on north side column pilaster.*

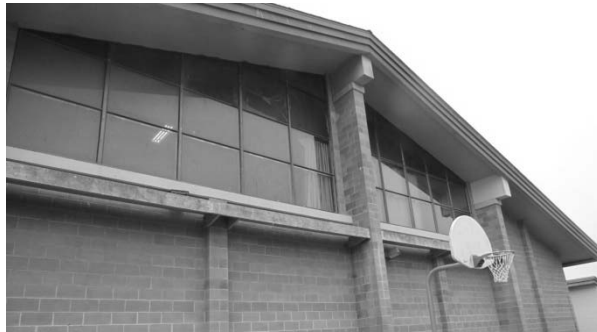
*The upper east facing windows for the gymnasium windows with blackout film which is looking in poor condition. Given desire for less windows to reduce glare in gym, a better solution and energy efficient measure would be to replace upper glazed panels with insulated opaque panels.*

*East facing fenestration*

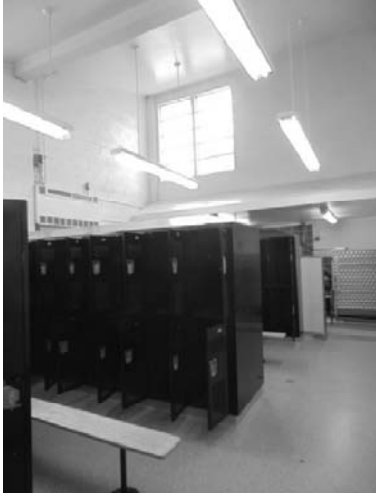
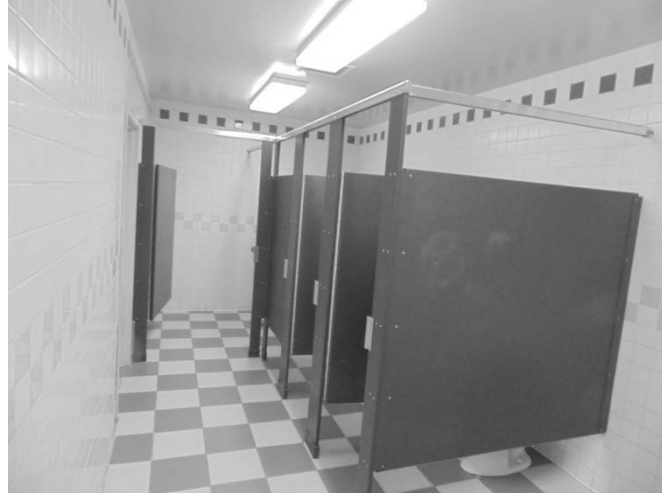
### ***Girls restrooms (serving locker room and gymnasium)***

**Walls:** are full height ceramic tile with some darkening of grout lines toward base of walls but generally in great condition.

**Floor:** Vinyl composition tile in a checker board pattern likely installed in early 2000's modernization. Tiles showing some incidental signs of separating and yellowing but generally in good condition.

**Toilet Accessories:** mirrors in good condition, no signs of loss of silver. paper towel soap and toilet paper dispensers appear to be in like new condition. Toilet Paper dispenser may be slightly out of compliance with current ADA standards.
