**POINT ARENA  
SCHOOLS DISTRICT**

**FACILITY ASSESSMENT**

July 2018

Alameida  
Architecture

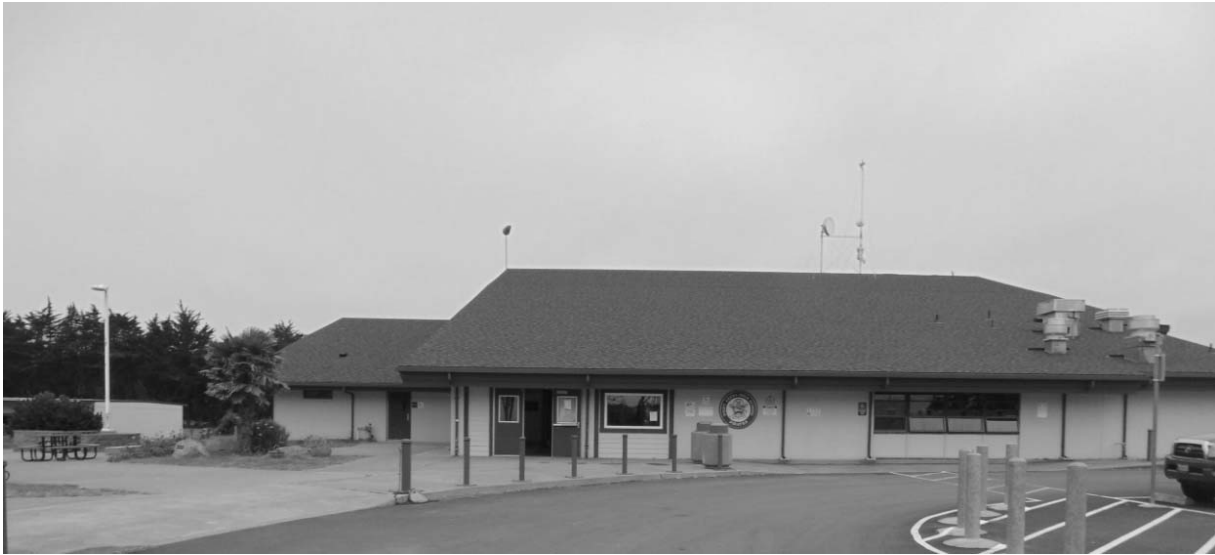
**HIGH SCHOOL GYMNASIUM, LOCKER ROOMS AND CAFETERIA**

The gymnasium building constructed circa 1968 and had a major modernization project completed around 2003. The facility is in generally very good condition. DSA Application #29477, 1967 and modernized under DSA 01-102720, 2002.
